BLUENOSE INSPECTIONS HOME INSPECTION REPORT

1234 Main st.
Halifax, NS B3K2Y5

Buyer Name
07/28/2022 9:00AM

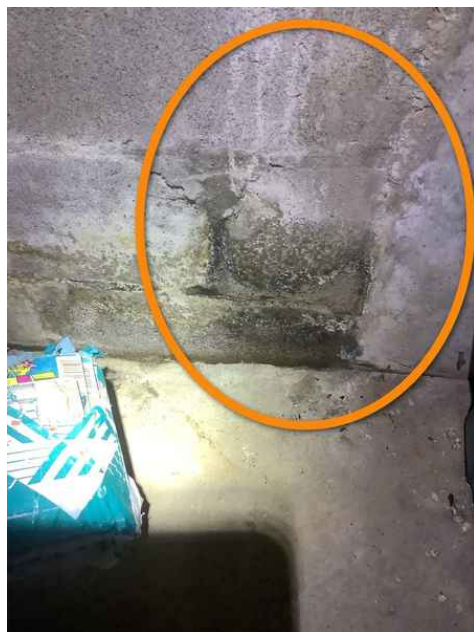
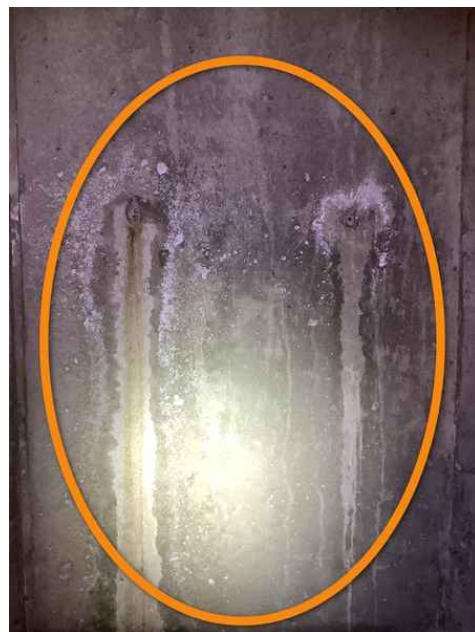
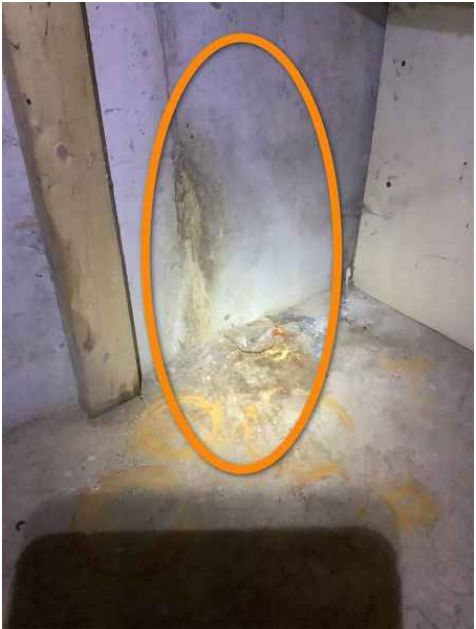
2.1.1 Foundations, Basement and Crawlspce (Report signs of abnormal or harmful water penetration into the building or signs of abnormal or harmful condensation on building components.)

The inspector noted evidence of white efflorescence and old water staining during inspection. Further evaluation is recommended.

Recommendation

Contact a qualified professional.

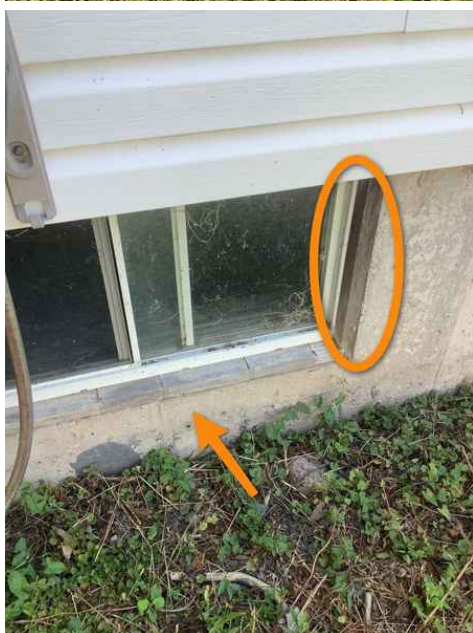
2.1.2 Foundations, Basement and Crawlspce (Report signs of abnormal or harmful water penetration into the building or signs of abnormal or harmful condensation on building components.)

CONCRETE SPALLING

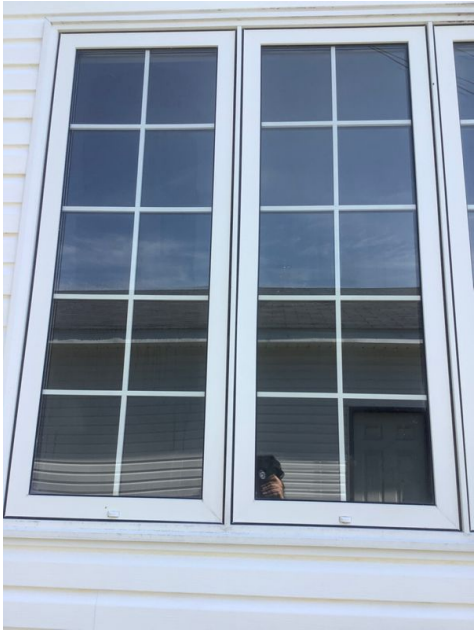
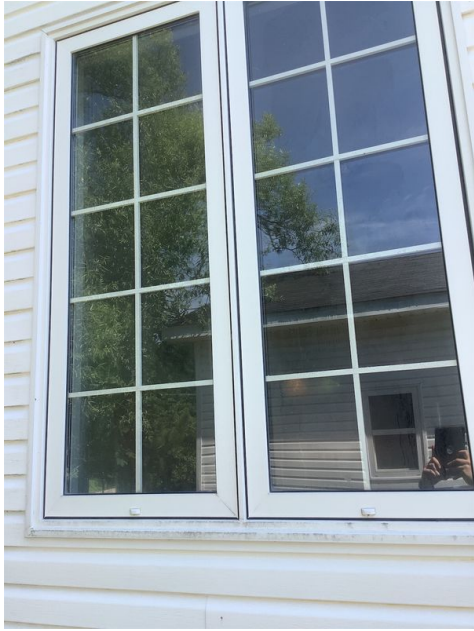
4.7.3 Windows (from exterior side)

DAMAGED THERMAL SEAL
