BLUENOSE INSPECTIONS HOME INSPECTION REPORT

1234 Main st.
Halifax, NS B3K2Y5

Buyer Name
07/28/2022 9:00AM

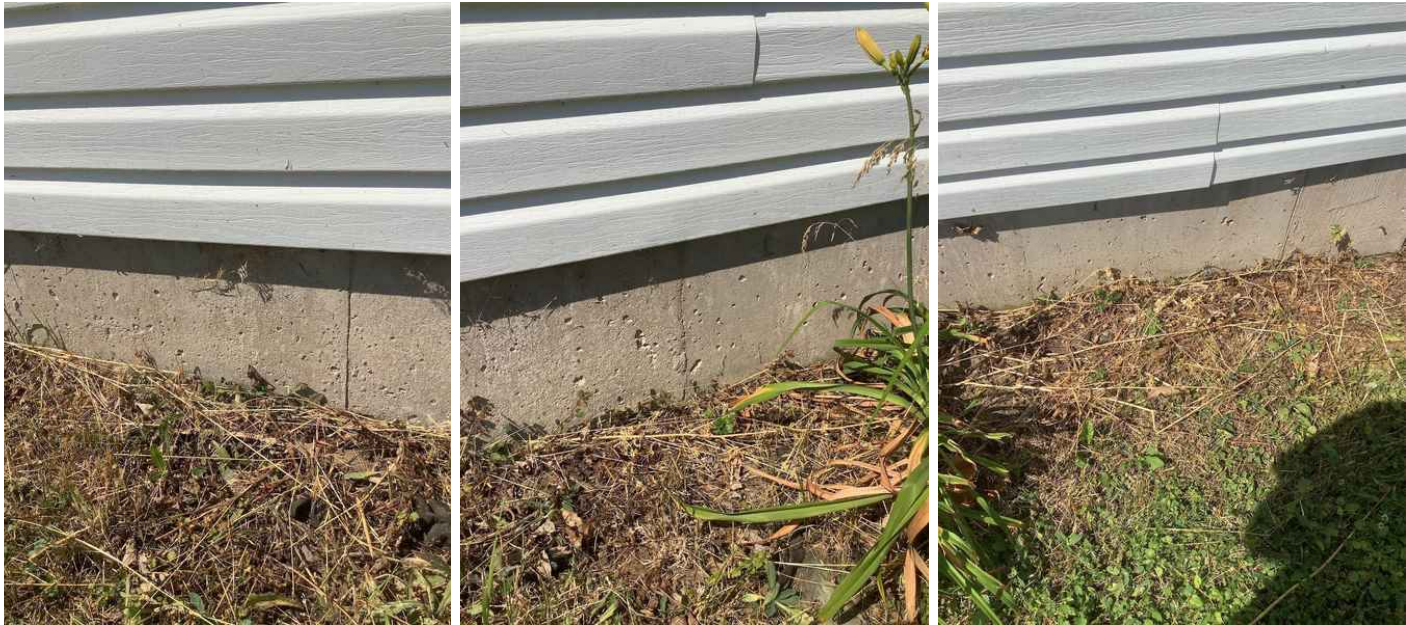
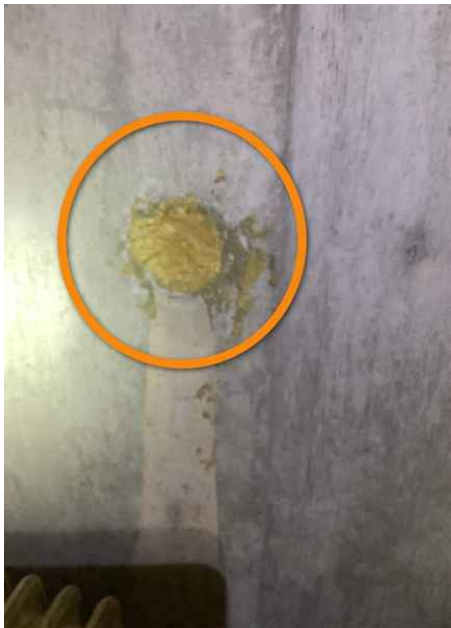
Suspected unprofessional repair

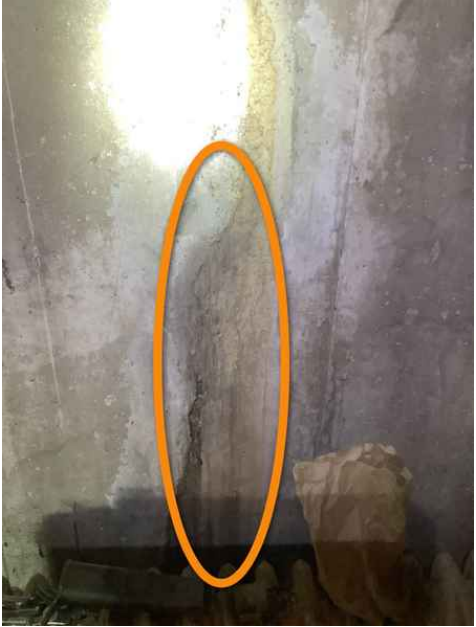
2.1.2 Foundations, Basement and Crawlspce (Report signs of abnormal or harmful water penetration into the building or signs of abnormal or harmful condensation on building components.)

CONCRETE SPALLING

Concrete spalling typically begins when the steel reinforcing embedded within the concrete member rusts. Contrary to popular belief, concrete is porous. Rusting of the embedded steel reinforcing occurs when that reinforcing bar is exposed to water and air; without both of these elements, the steel bar does not rust. When exposed to both of those elements, a chemical reaction takes place wherein iron oxide (rust) is produced. The production of iron oxide includes a volumetric expansion of the bar by up to 6 times the original volume, and that increase in volume imposes significant expansive forces upon the surrounding concrete. These expansive forces can cause the concrete to delaminate or to crack, spall, and break off.

Delamination and spalling of a concrete member are both undesirable conditions; they can reduce the cross sectional area of the concrete member and decrease its ability to safely carry imposed loads. An additional consideration is that both delamination and spalling offer increased access of air and water to the reinforcing steel within that member; thus creating a cycle of corrosion and increased access of the corrosive elements exacerbating the process with each subsequent cycle.

Contact a foundation contractor.

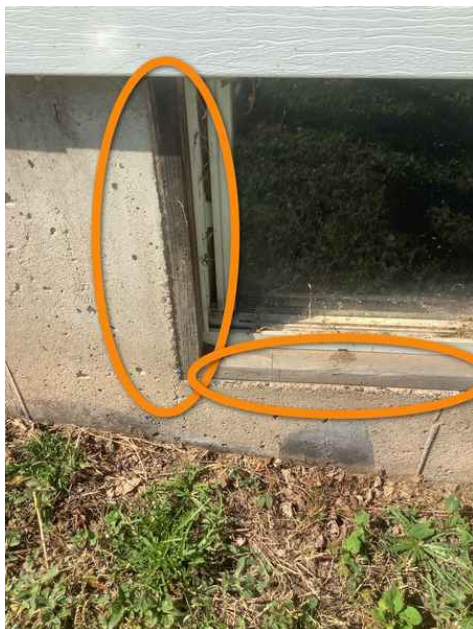
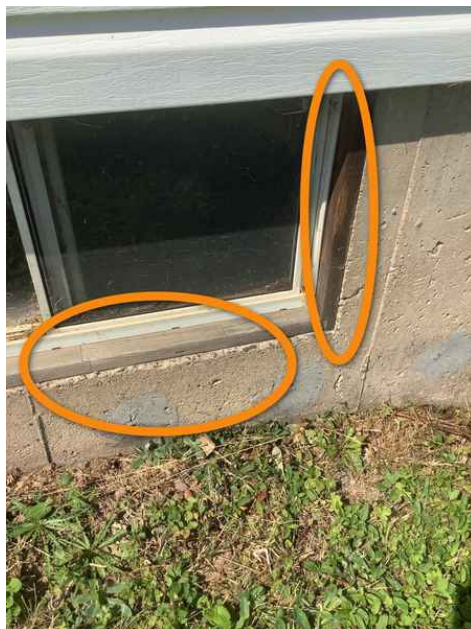
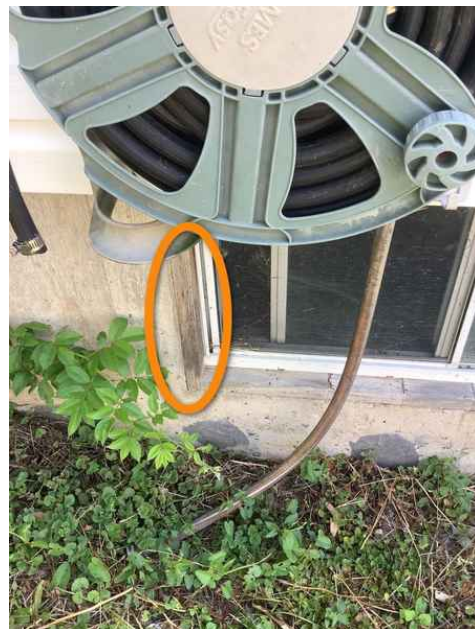
2.1.4 Foundations, Basement and Crawlspace (Report signs of abnormal or harmful water penetration into the building or signs of abnormal or harmful condensation on building components.)

2.1.4 Structural Systems - Foundations, Basement and Crawlspcace (Report signs of abnormal or harmful water penetration into the building or signs of abnormal or harmful condensation on building components.): Previous Foundation Repair Observed.

Contact a foundation contractor.

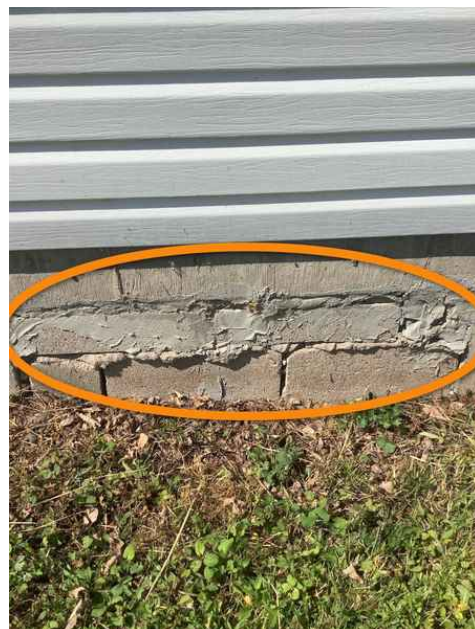
2.1.5 Foundations, Basement and Crawlspace (Report signs of abnormal or harmful water penetration into the building or signs of abnormal or harmful condensation on building components.)

2.1.5 Structural Systems - Foundations, Basement and Crawlspcace (Report signs of abnormal or harmful water penetration into the building or signs of abnormal or harmful condensation on building components.): Vertical Crack in the Foundation Wall

Contact a foundation contractor.

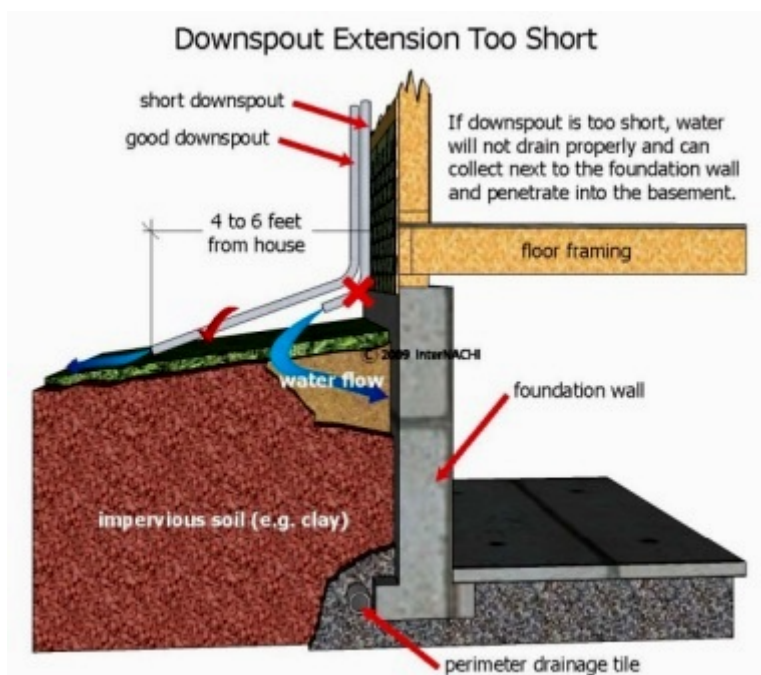
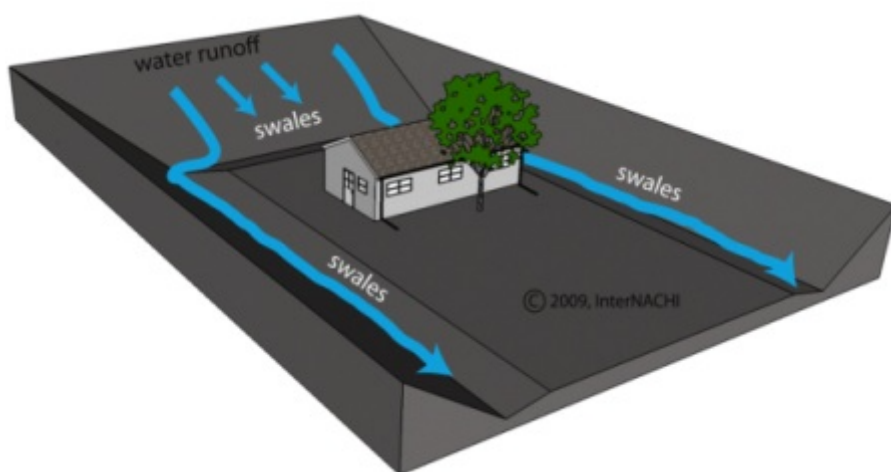
2) The finish grade should be sloped away from the building for 10 to 15 feet. Low spots that may lead to water pooling should be evened out to prevent the possibility of standing water near the foundation.

3) Shallow ditches called swales should be used in conditions where one or more sides of the building face an upward slope. A swale should slope away from the building for 10 to 15 feet, at which point it can empty into another swale that directs water around to the downhill-side of the building, leading it away from the foundation.

If leaks or seepage is occurring in the basement's interior, water and moisture are most likely entering through small cracks or holes. The cracks or holes could be the result of several things. Poor workmanship during the original build may be making itself apparent in the form of cracks or holes. Water pressure from the outside may be building up, forcing water through walls. The house may have settled, causing cracks in the floor or walls. Repairing all cracks and small holes will help prevent leaks and floods.

-Repair all cracks and holes.

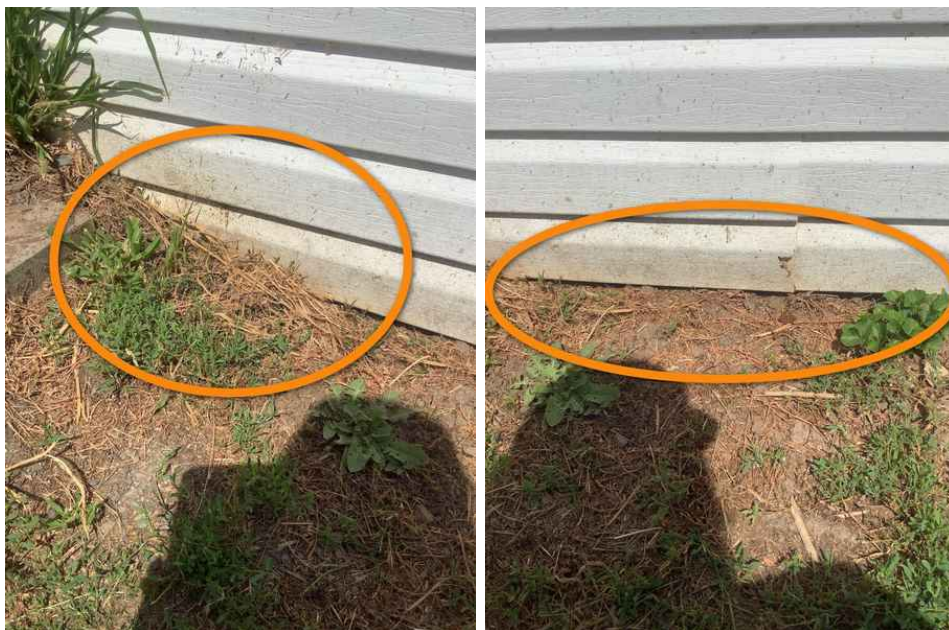
4.1.2 Wall covering(s) Flashing and Trim

EXTERIOR SHOWN IN GOOD CONDITION.

With the exception of the noted areas, The siding is shown in good condition with only minor stains and damage

There were no signs of major damage or loose or missing sections of siding during the inspection.

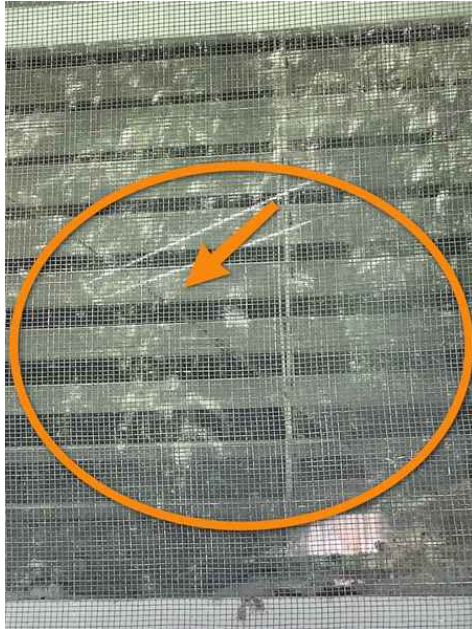
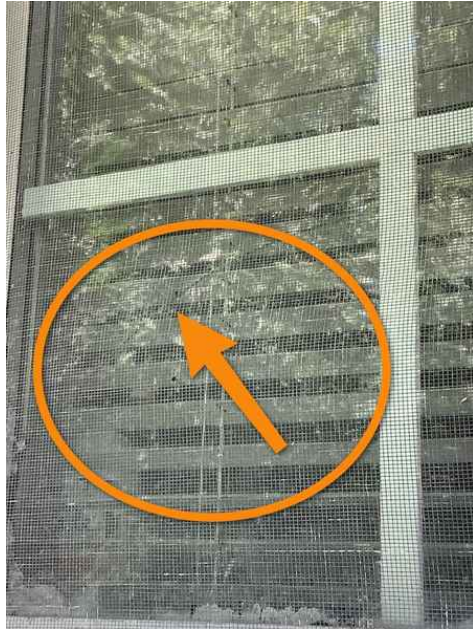
4.7.3 Windows (from exterior side)

DAMAGED THERMAL SEAL

These noted exterior windows are shown with moisture/condensation can be seen on the panes of several exterior windows during the inspection.

There were no signs of leaks or damage to the interior of the home from the windows, during the inspection, however a broken seal can reduce the "R" value (insulation value) of the window and is less energy efficient

It would be recommended to contact a professional window repair / replacement company to quote the cost and scope of the required repair prior to owning the home.

Contact a qualified window repair/installation contractor.

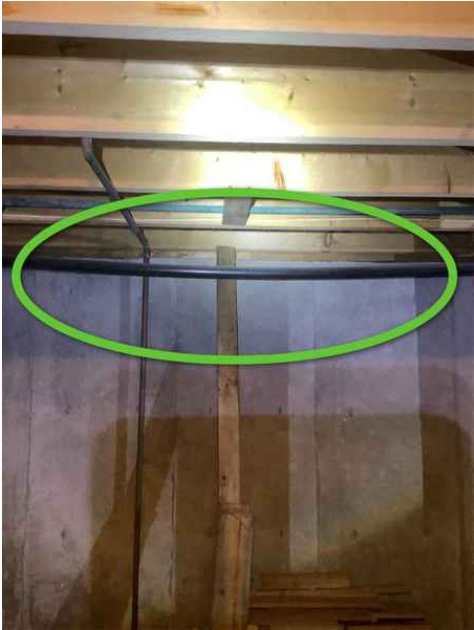
5.2.2 Plumbing Drain, Waste and Vent Systems

ABS main stack shown with ABS waste drains shown to be installed as well.

The ABS is shown to provide functional drainage and there were no signs leaks or damage during the inspection.

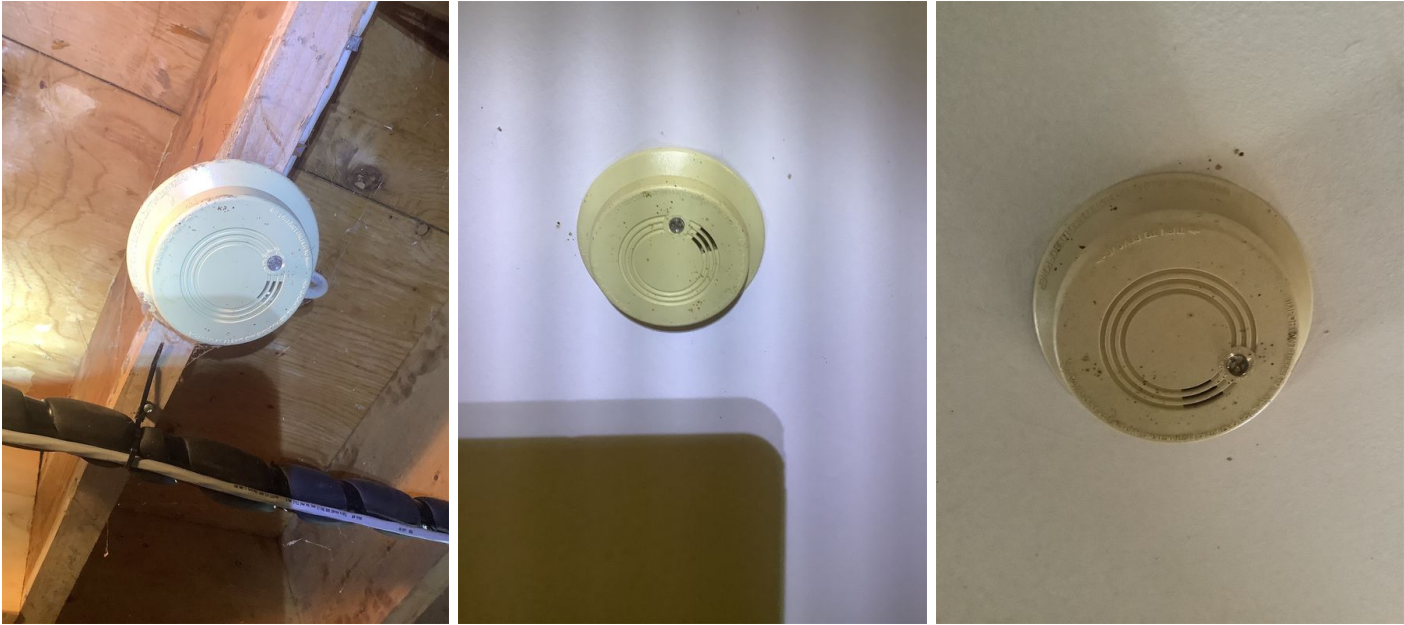
Smoke Detectors: Expired Smoke Detector

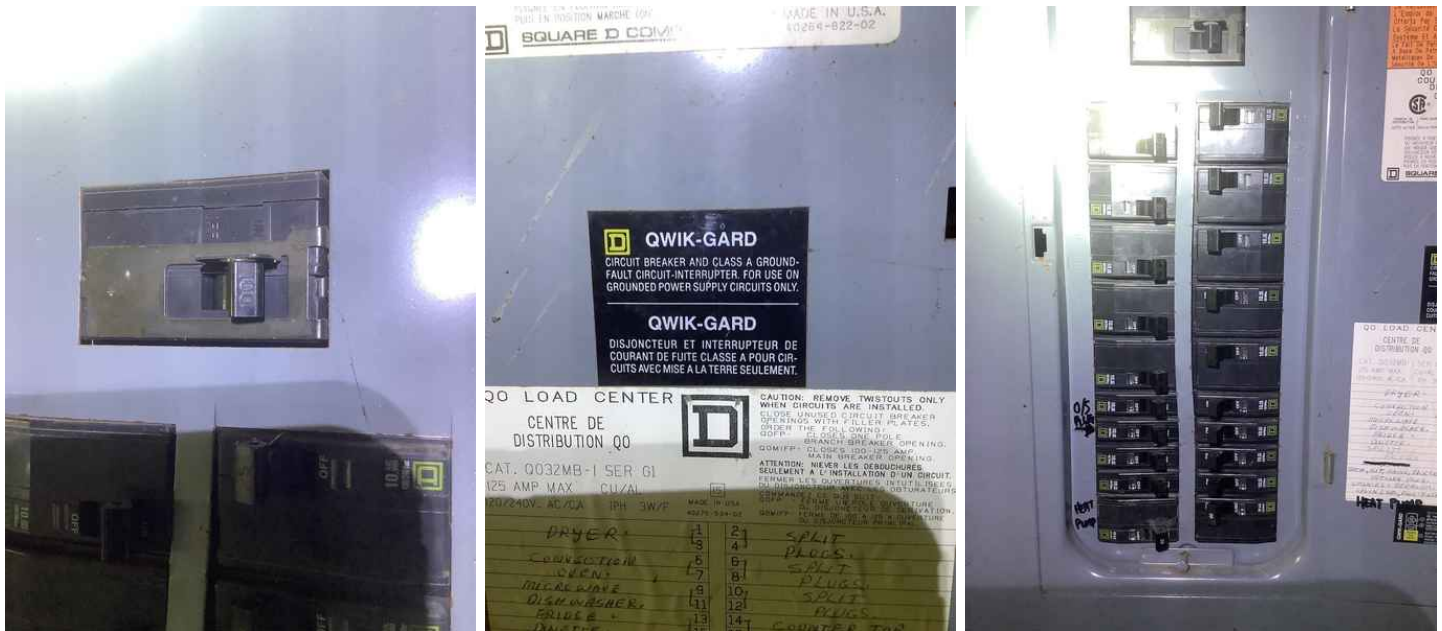
6.2.1 Service and Grounding Equipment, Main Overcurrent Device, Main and Distribution Panels

ELECTRICAL PANEL

100 AMP Labeled Circuit panel shown in good condition with no signs of corrosion or damage

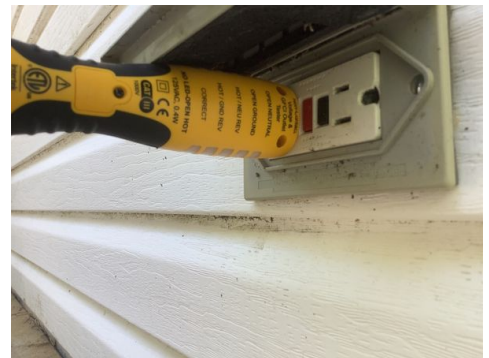
6.3.1 Connected Devices and Fixtures

The receptacle on the exterior were found to not function as expected during the inspection

The inspector notes that all receptacles were turned on at the panel and the inspector recommends further evaluation and repair as required by a professional electrician.

Contact a qualified electrical contractor.

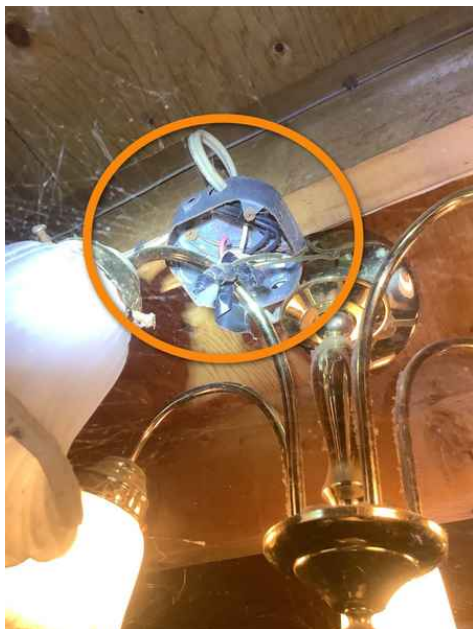
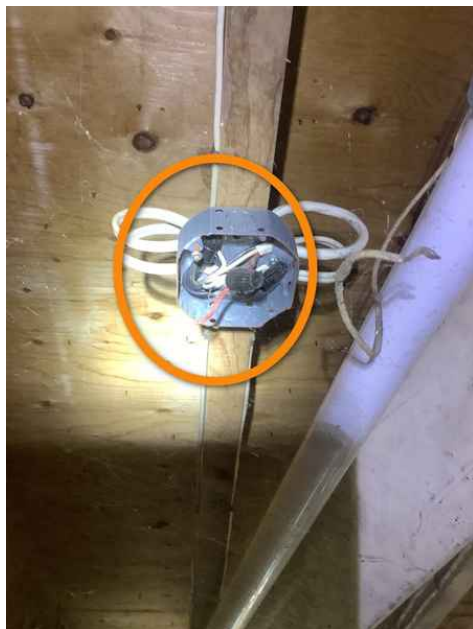
6.3.2 Connected Devices and Fixtures (Observed from a representative number operation of ceiling fans, lighting fixtures, switches and receptacles located inside the house, garage, and on the dwelling's exterior walls)

SHOCK HAZARD

Contact a qualified electrical contractor.

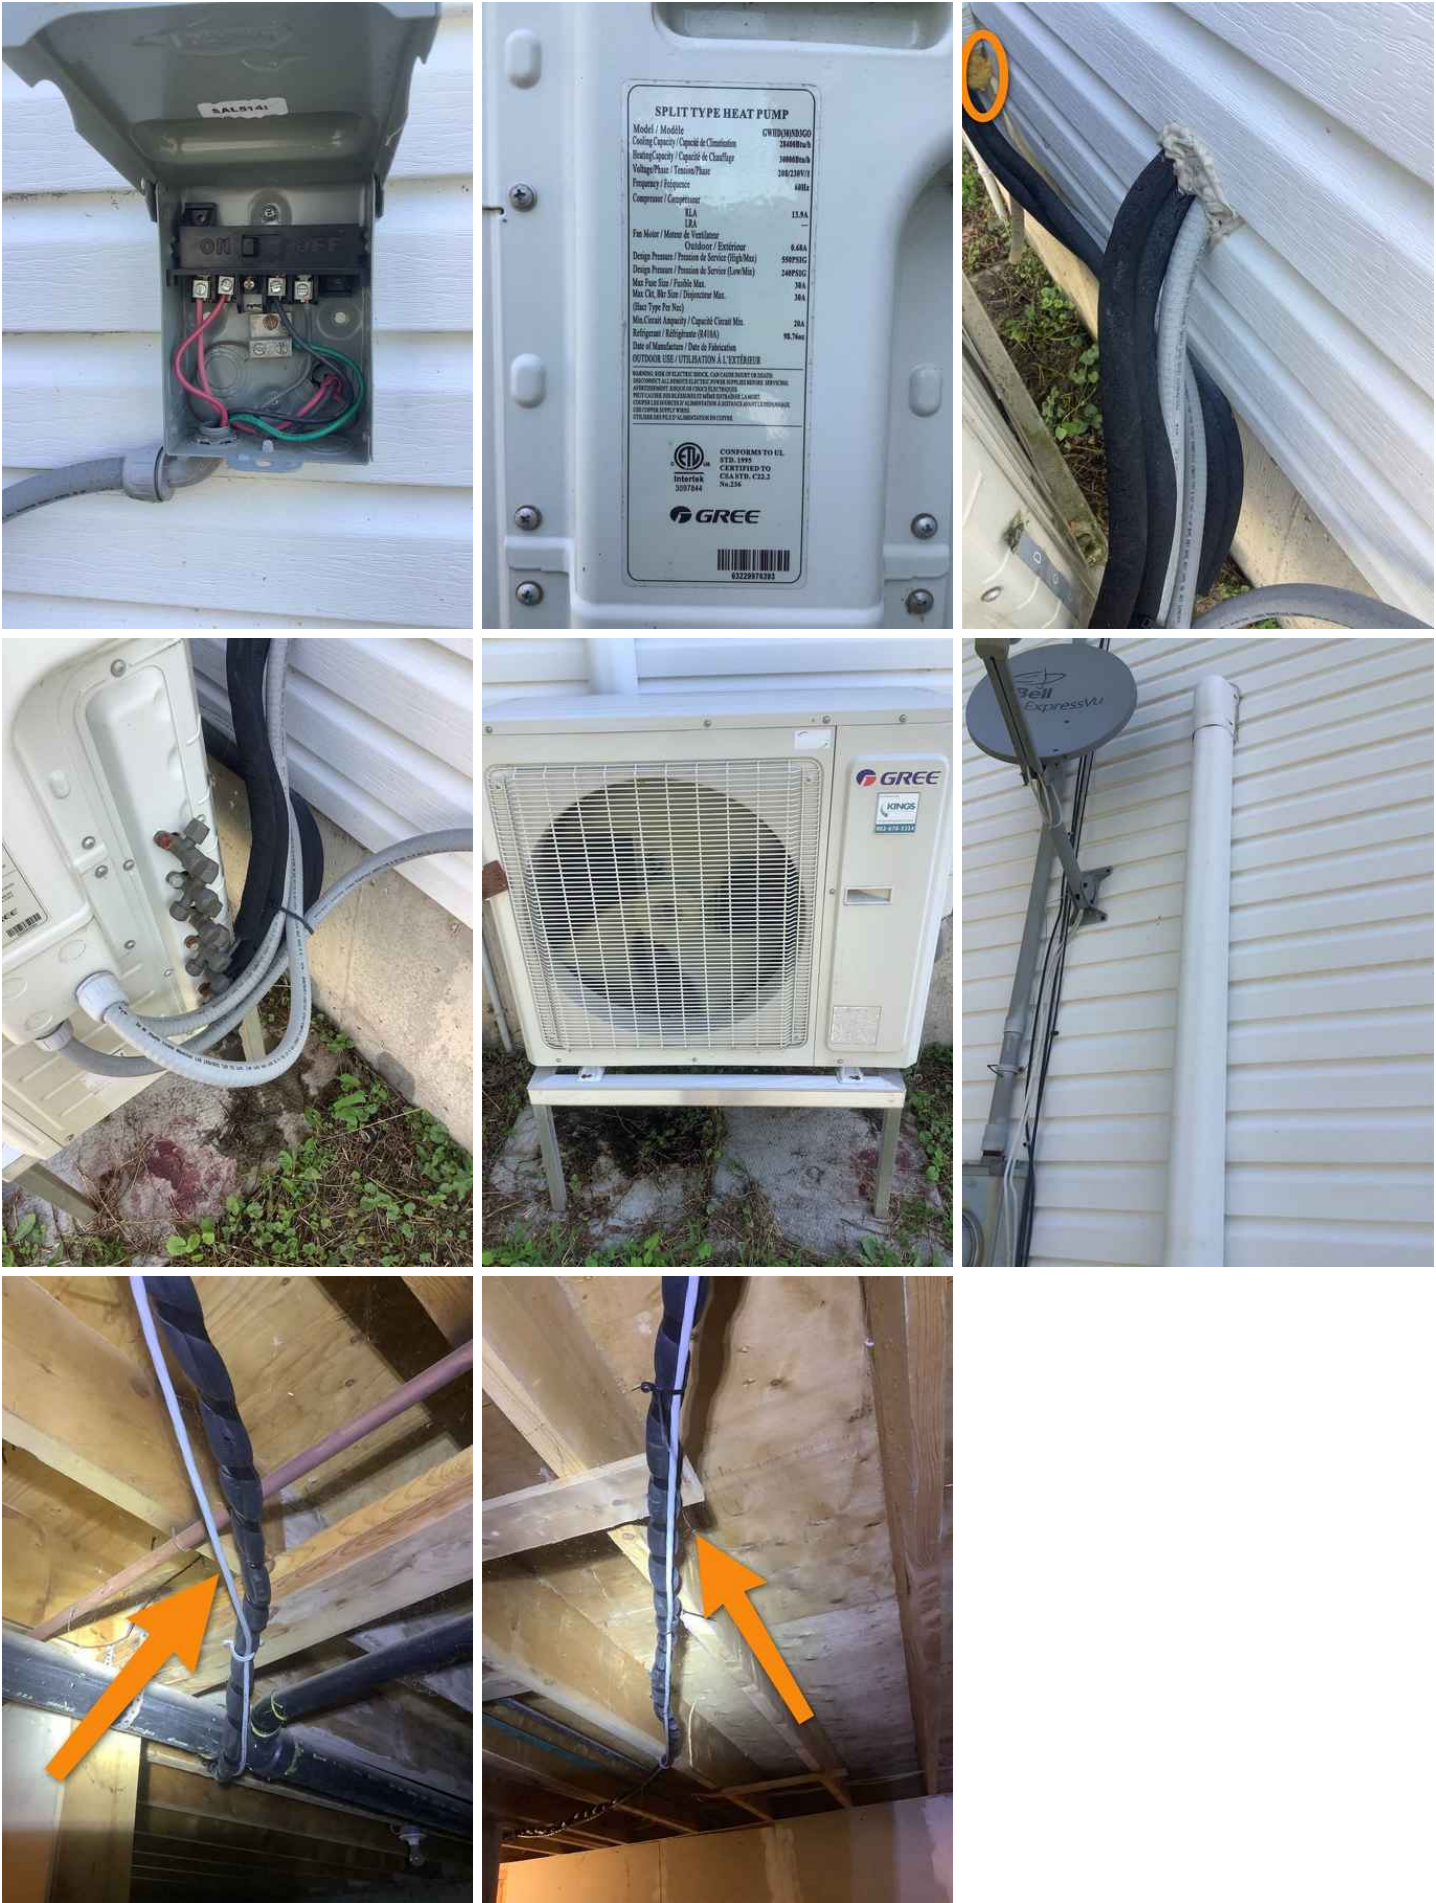
7.1.4 Heating Equipment

COOL AIR HEAT PUMP

Contact a qualified professional.

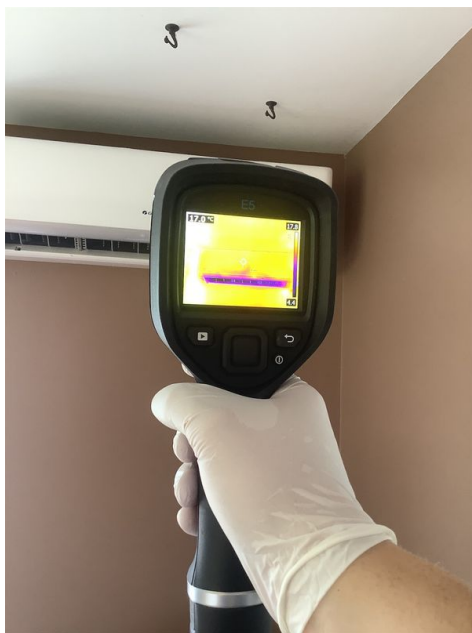
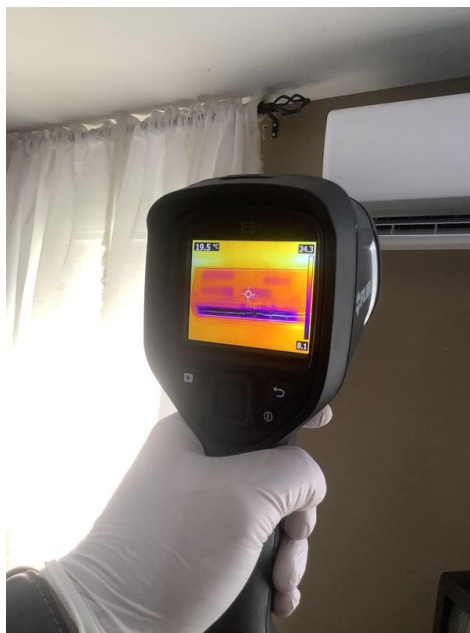
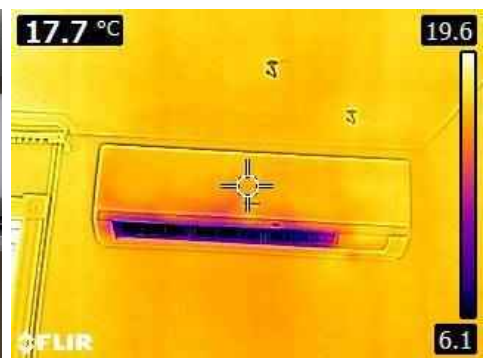
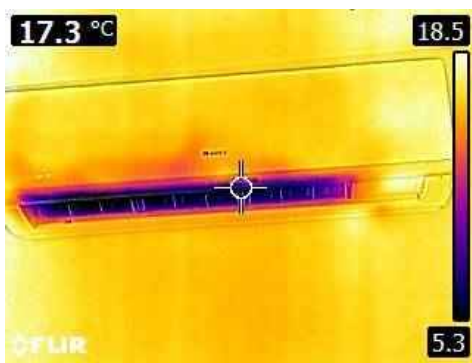
7.2.1 Presence of Installed Heating/Cooling Source in Each Room

NO HEAT SOURCE ROOMS

Contact a qualified professional.

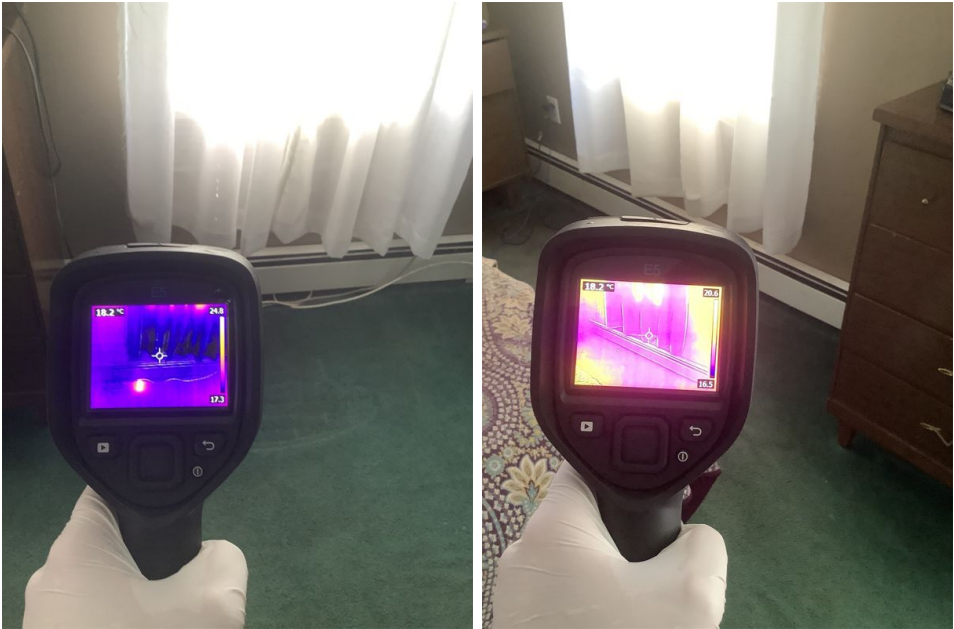
7.2.2 Presence of Installed Heating/Cooling Source in Each Room

ALL SOURCES OF HEAT ARE CONFIRMED TO OPERATE AS EXPECTED DURING THE INSPECTION

With the exception of the noted no heat in the bedroom, all sources of heat in each room are shown to operate and return heat as expected during the inspection.

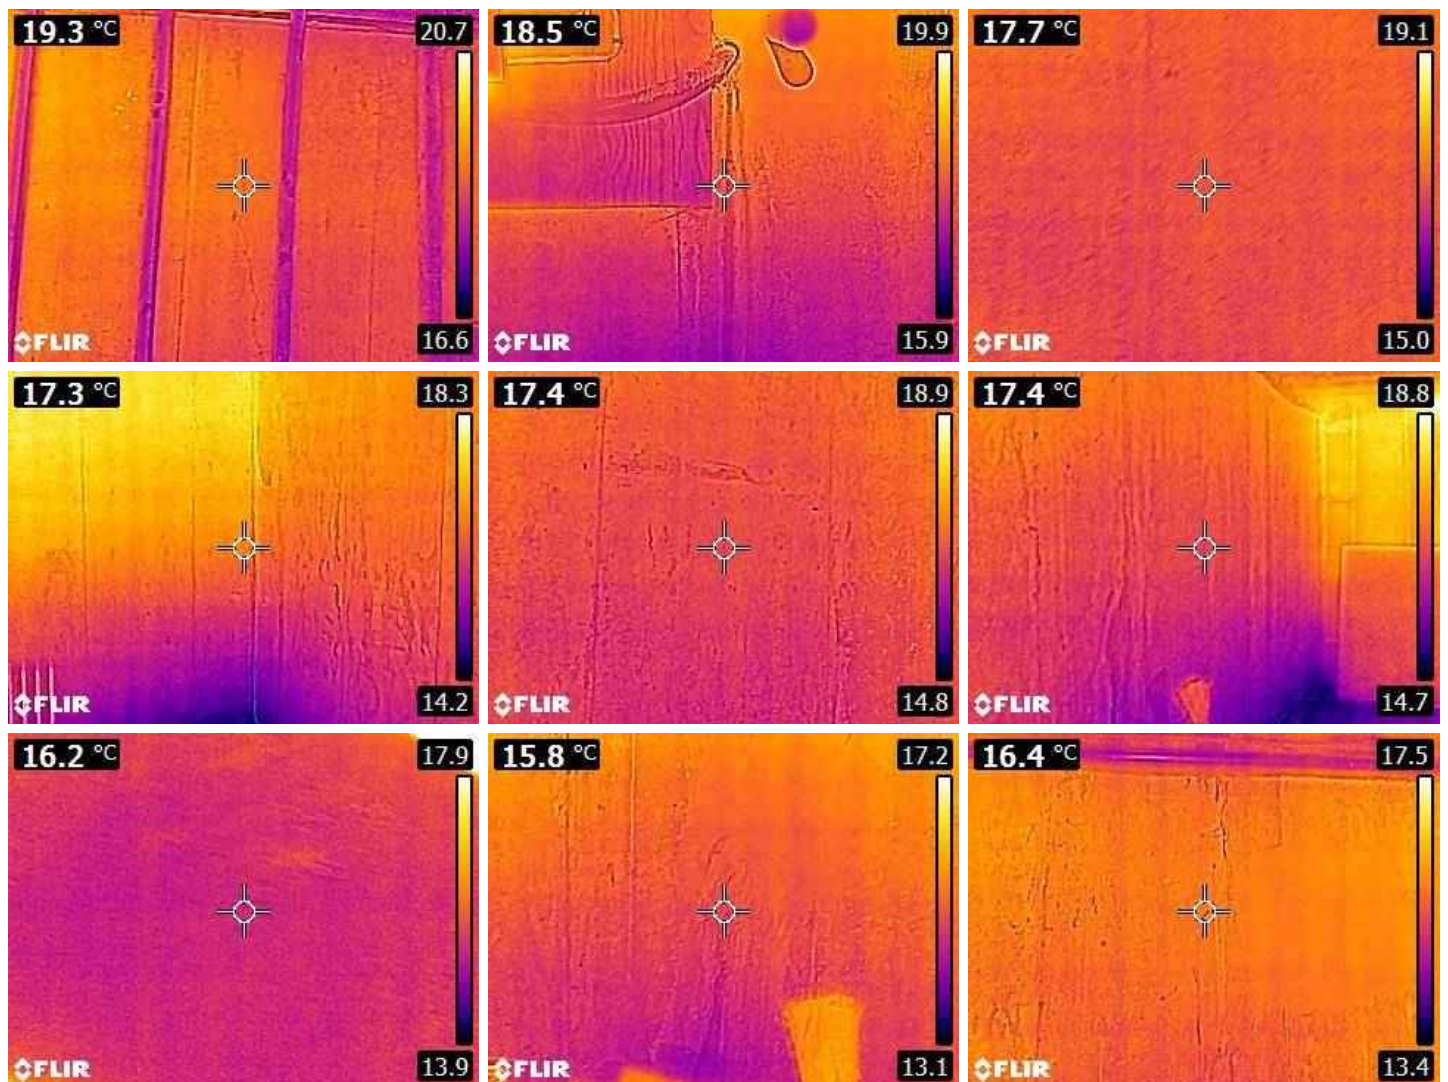
8.1.1 Walls

INTERIOR WALLS SHOWN IN GOOD CONDITION

Minor damage is shown to the walls of the home during the inspection

The inspector suspects past water entry in the basement due to evidence of drywall being removed and only wall framing left in the basement, and the previously noted staining on the inside portion of the foundation wall.

Contact a qualified professional.

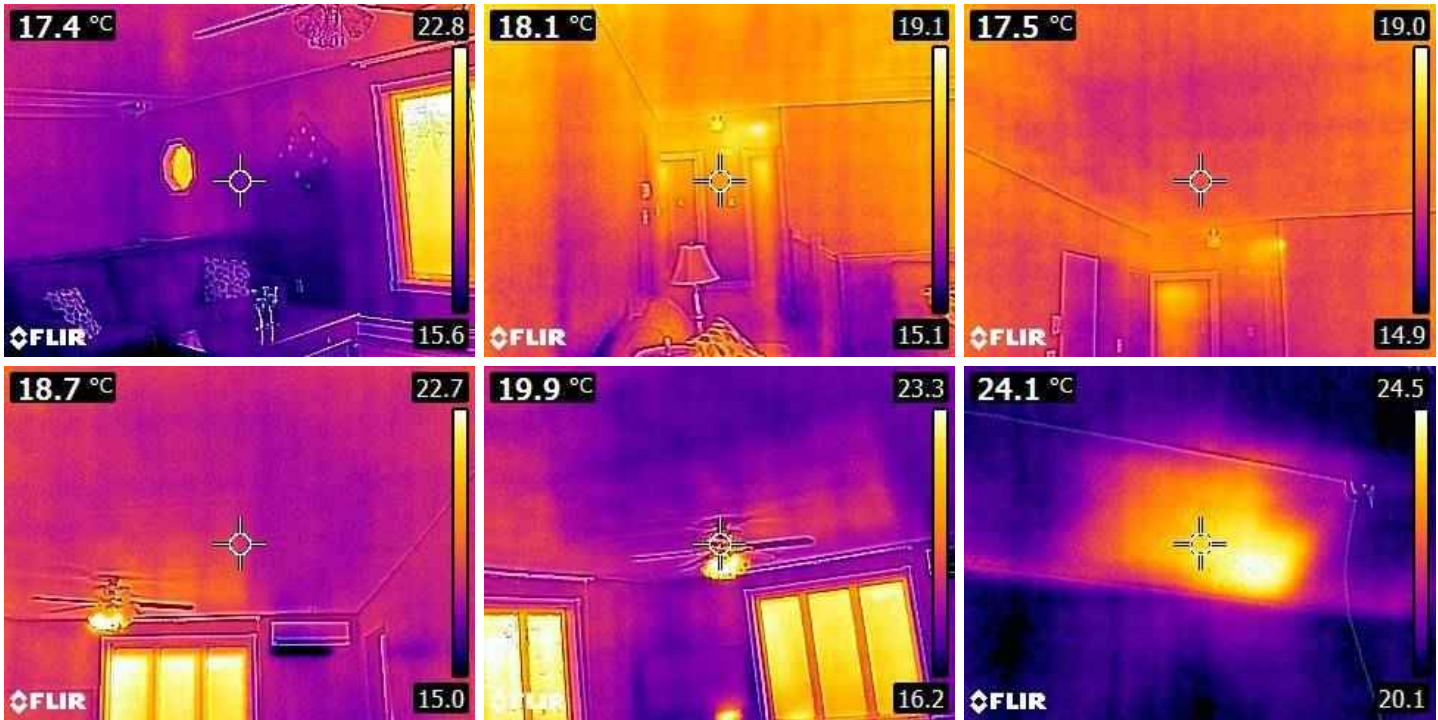
8.2.1 Ceilings

CEILINGS IN THE HOME

The ceilings in the home are shown in good condition.
There are some minor cracks in the dry wall, and some minor stains that would be normal to a lived in home.

There were no signs of active water stains, or major structural damage during the inspection.

Further evaluation is recommended.

Recommendation
Contact a qualified professional.

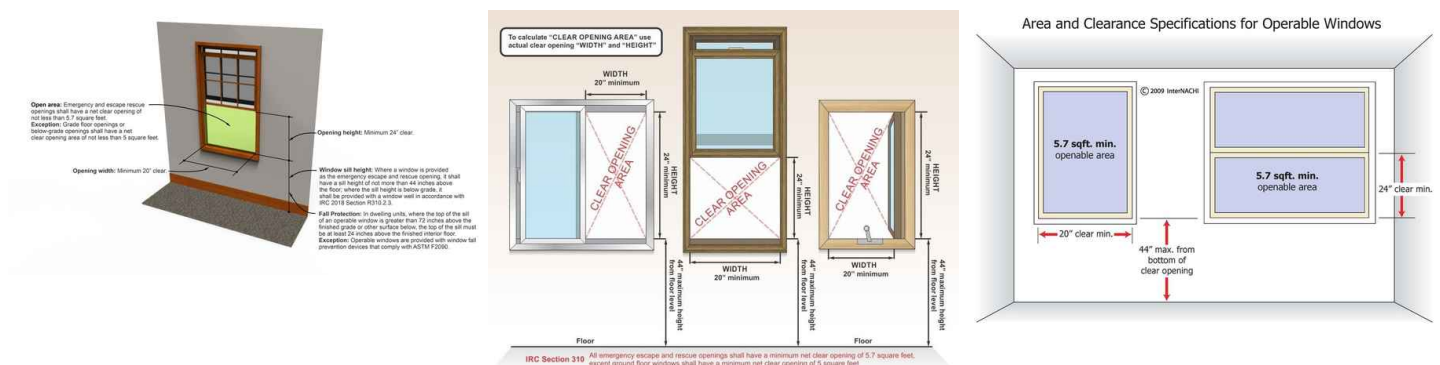
8.7.1 Windows (representative number)

EGRESS BASEMENT WINDOWS

Contact a qualified window repair/installation contractor.

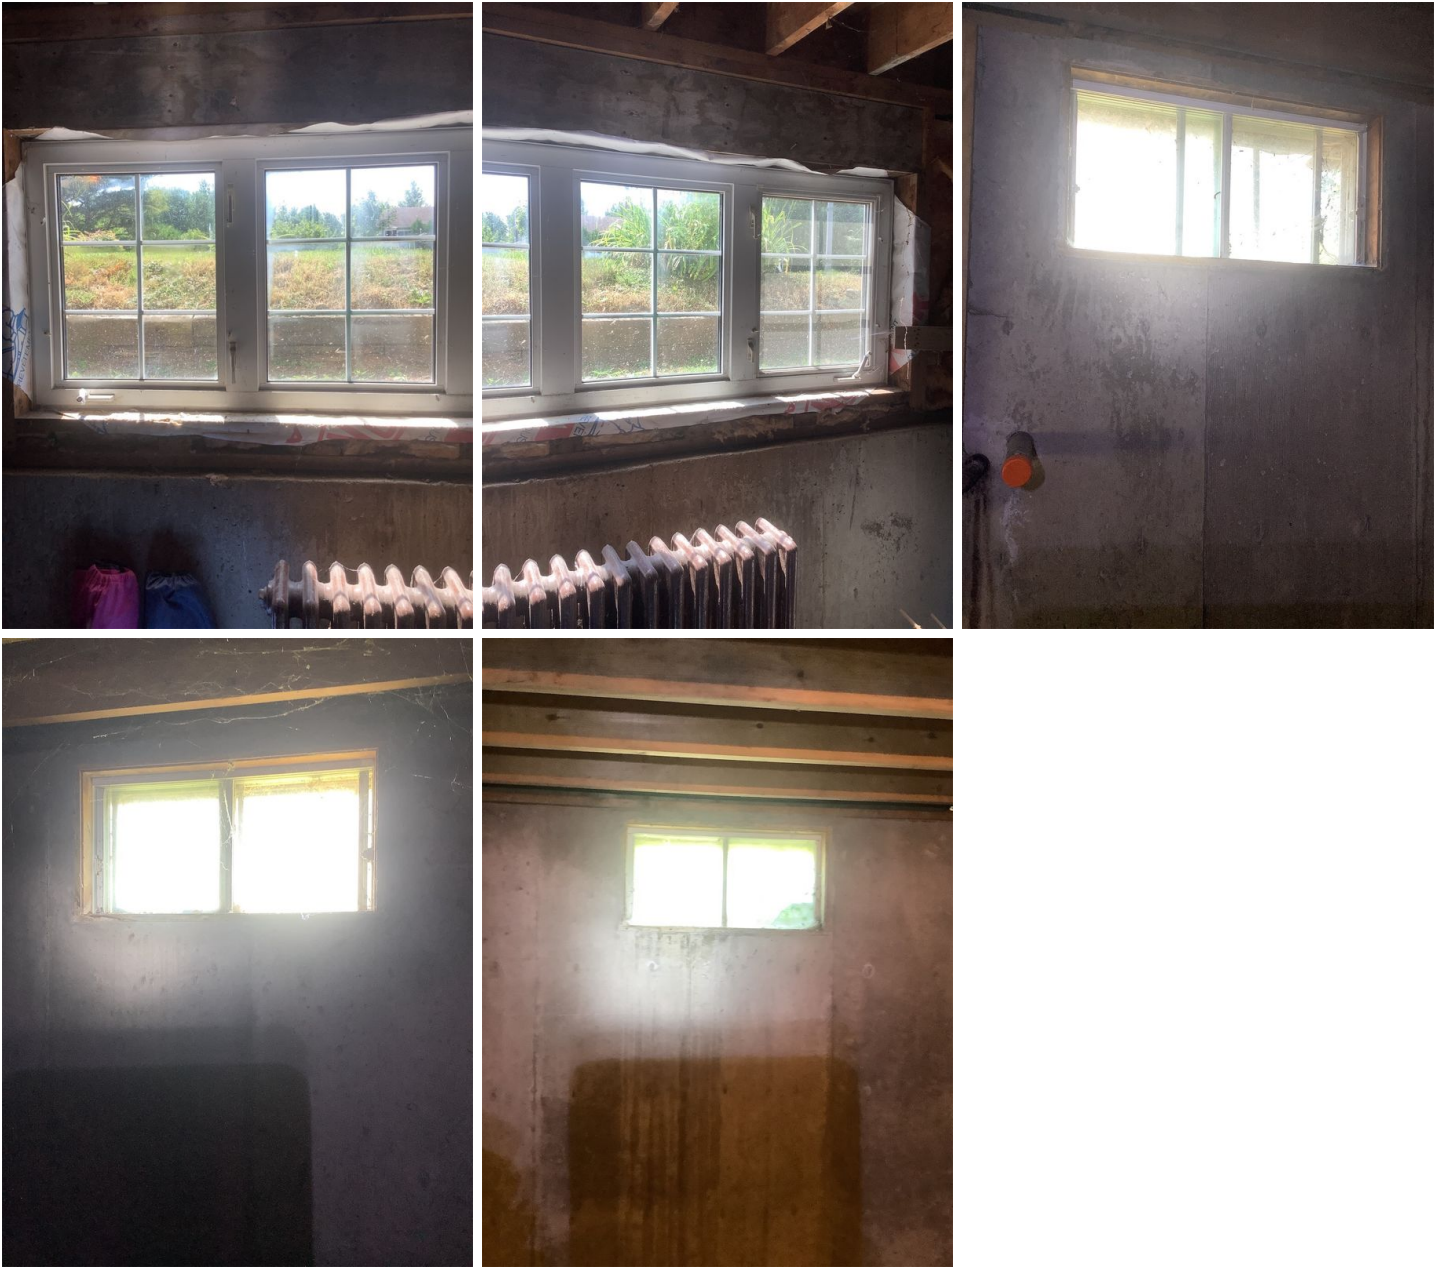
8.7.2 Windows (representative number)

NON-FUNCTIONAL WINDOWS

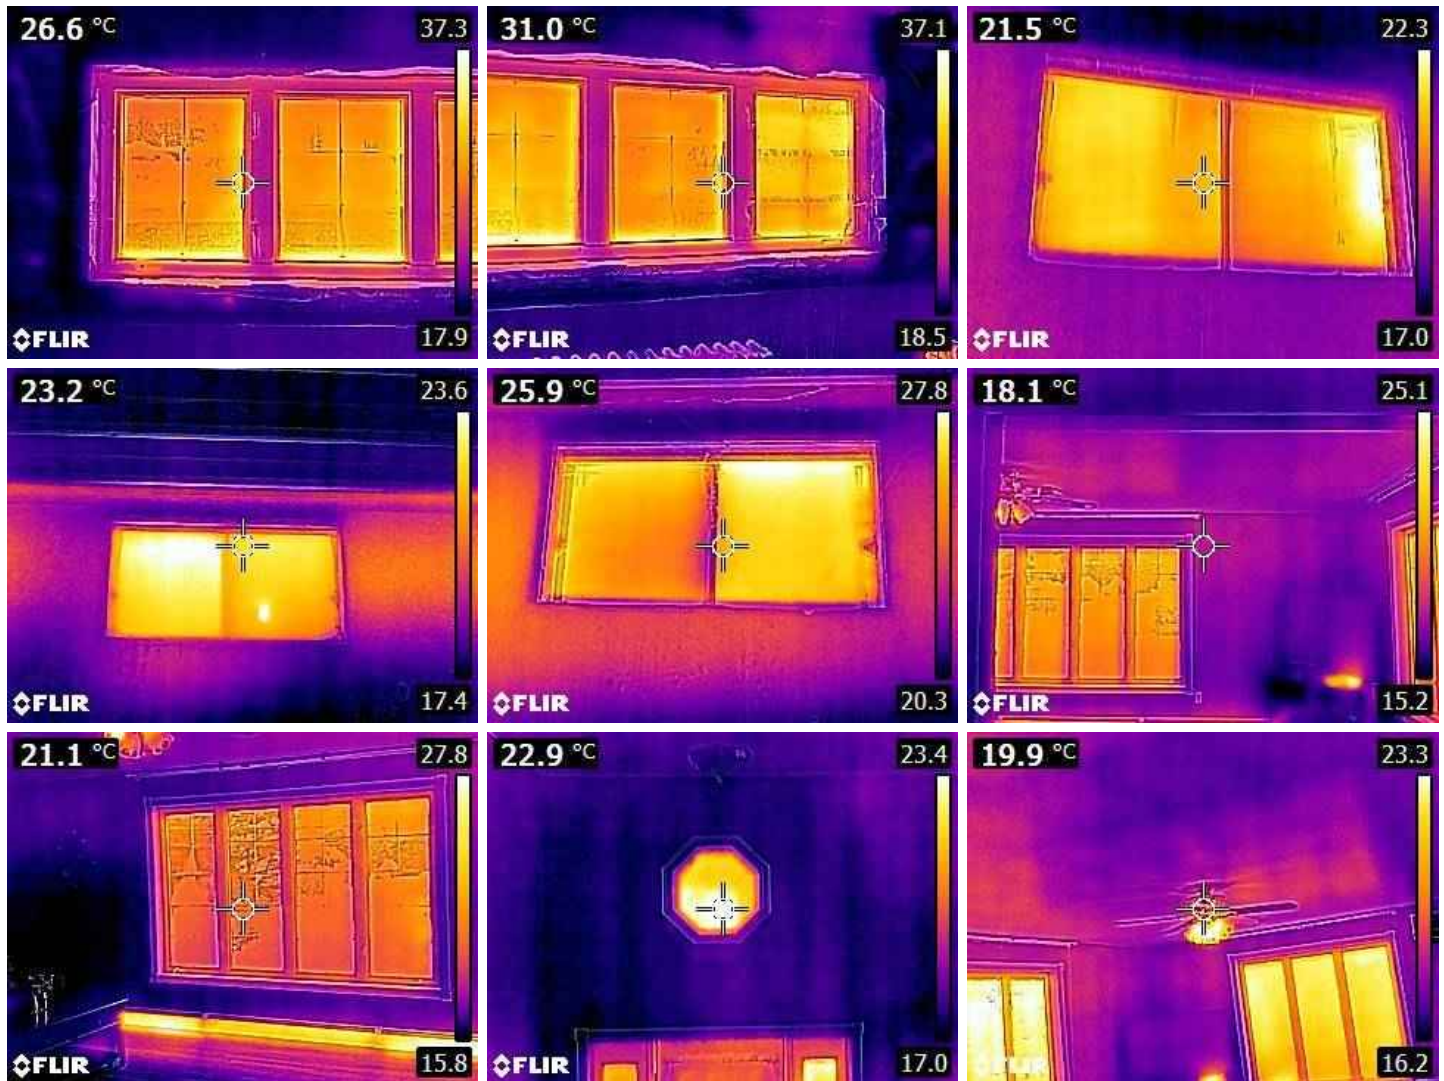
8.7.3 Windows (representative number)

WINDOW THERMAL IMAGES

Contact a qualified professional.

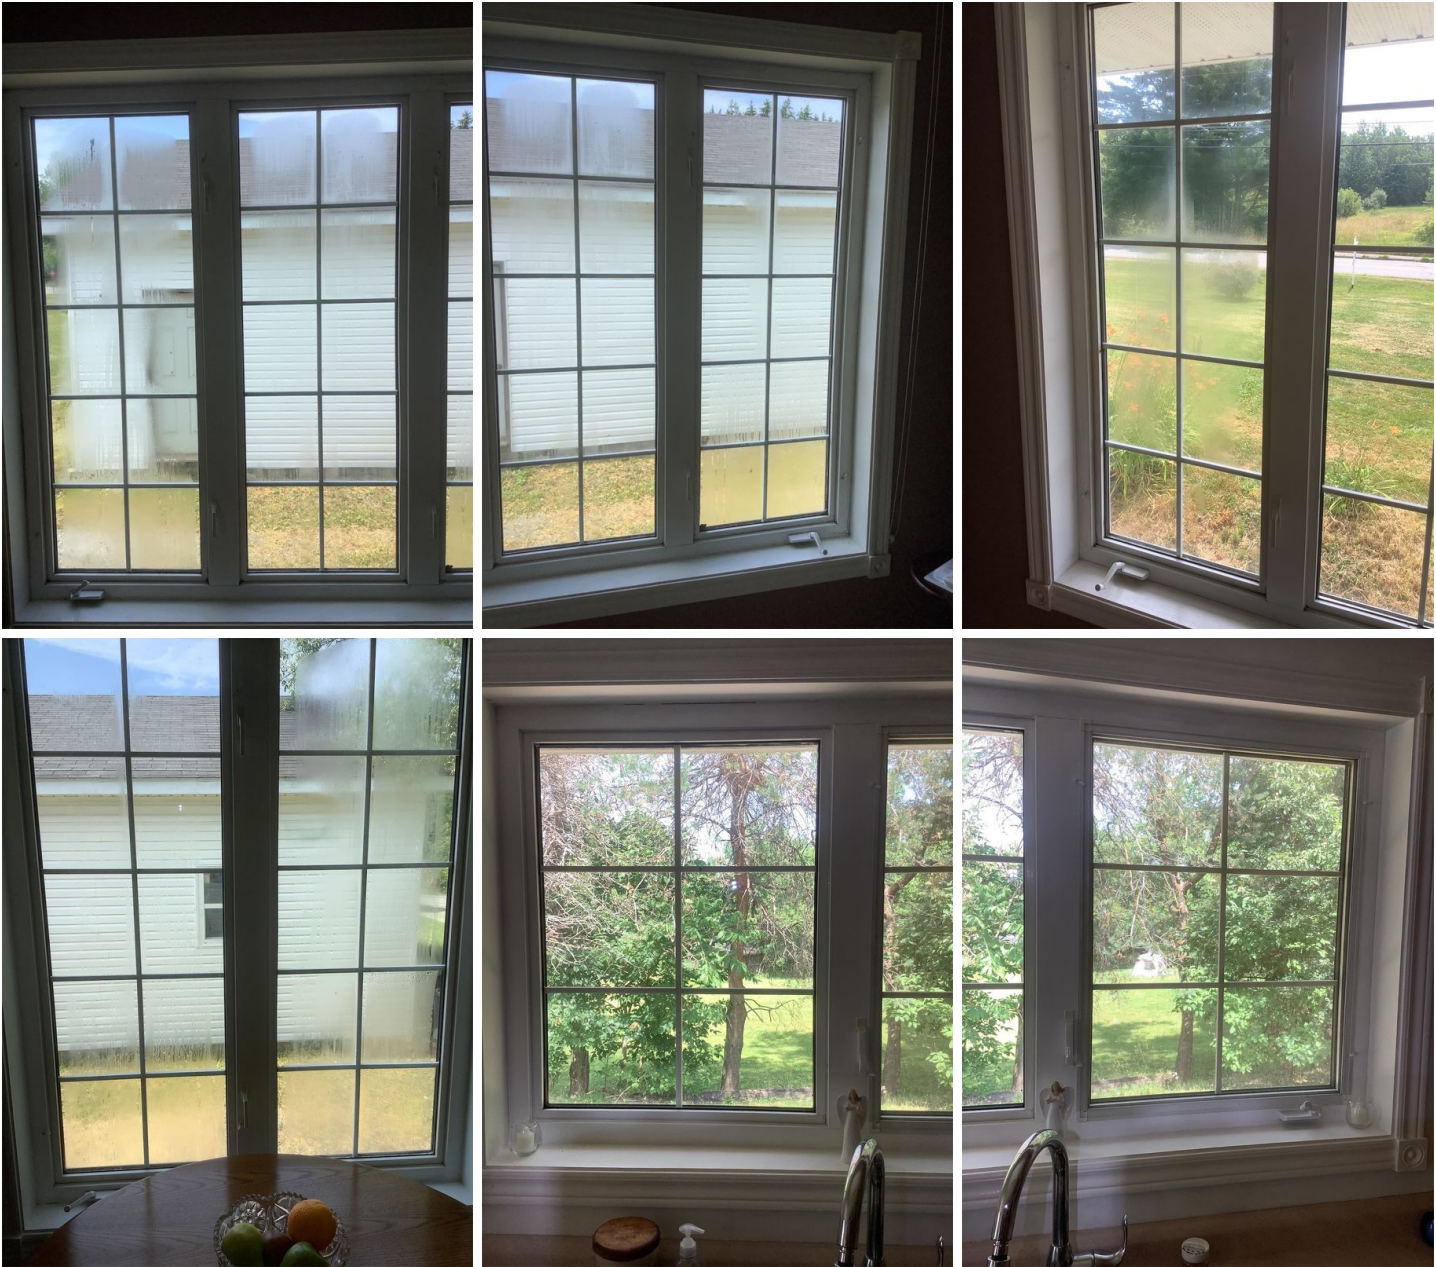
8.7.4 Windows (representative number)

FOGGED INTERIOR WINDOW(S)
